Recommended Service
Bulletin
No. RSB-E4-018

Inspection of engine harness.

Engine affected: E4 Series

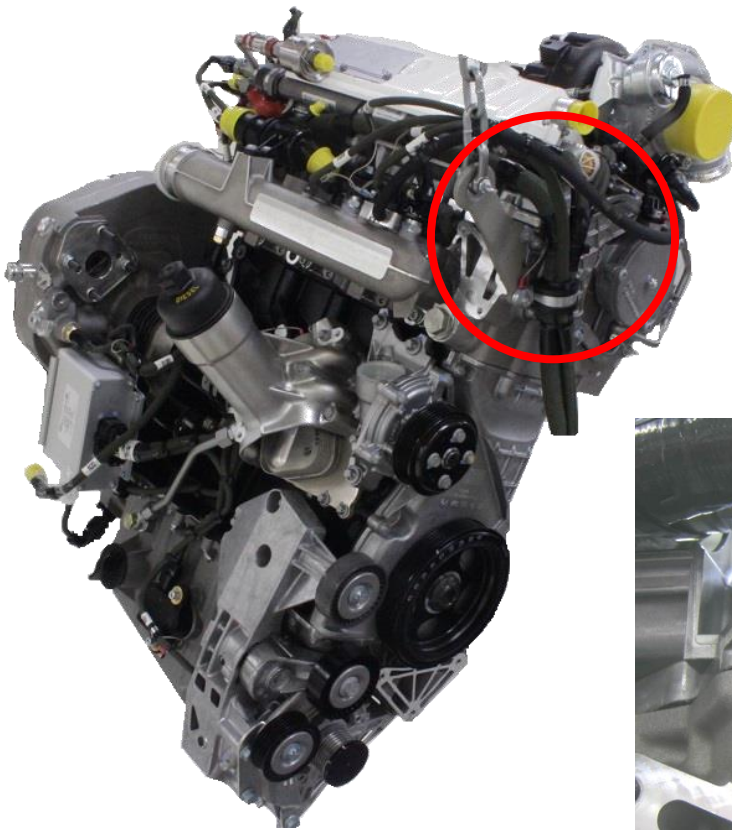
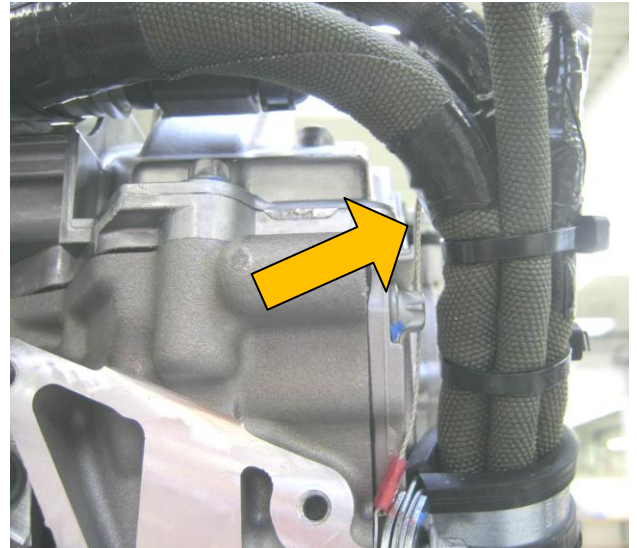
Operating experience revealed that improper engine harness routing may result in chafing at some installations, which could lead to short time overloads in the wiring resulting in possible loss of engine controllability.

Check engine wiring harness for proper routing according to Maintenance Manual E4.08.04 chapter 71-50-02 at the following area:

Especially check for sufficient clearance and ensure this clearance regardless of installation specific modifications (e.g. brackets).

Contact Austro Engine GmbH. in case of detected chafe marks for further instructions.
